TEST REPORT

Technical evaluation of tennis courts surfaces

Tests performed according to ASTM F3189 Standard

Report Number R18195CAN-B1

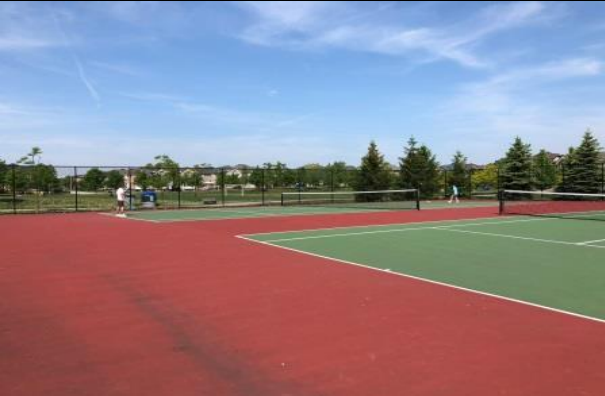
Location 1			
Installation	Willowheights Park, Markham, ON		
Product installed	<i>Information not provided</i>		
Installer	<i>Information not provided</i>		
Declared thickness	<i>Information not provided</i>		
Date of installation	<i>Information not provided</i>		
Date of test	May 30 th , 2018		
Temperature (°C)	23	Humidity (%)	55

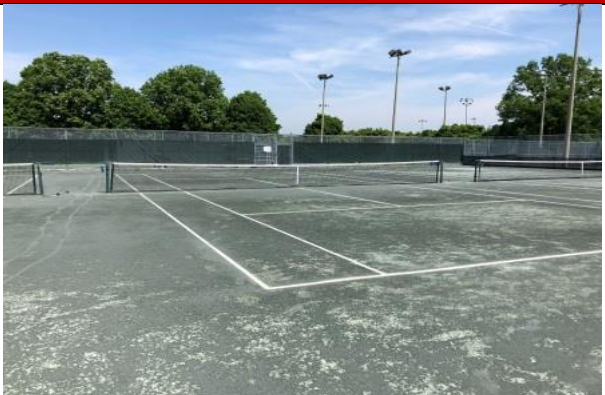
Location 2			
Installation	Unionville Tennis Club, Unionville, ON		
Product installed	<i>Information not provided</i>		
Installer	<i>Information not provided</i>		
Declared thickness	<i>Information not provided</i>		
Date of installation	<i>Information not provided</i>		
Date of test	May 30 th , 2018		
Temperature (°C)	27	Humidity (%)	56

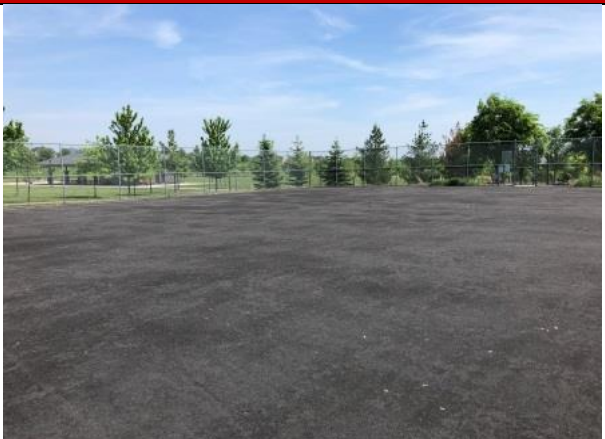
Location 3			
Installation	Berczy Park North, Markham, ON		
Product installed	<i>Information not provided</i>		
Manufacturer	<i>Information not provided</i>		
Declared thickness	<i>Information not provided</i>		
Date of installation	<i>Information not provided</i>		
Date of test	May 30 th , 2018		
Temperature (°C)	29	Humidity (%)	56

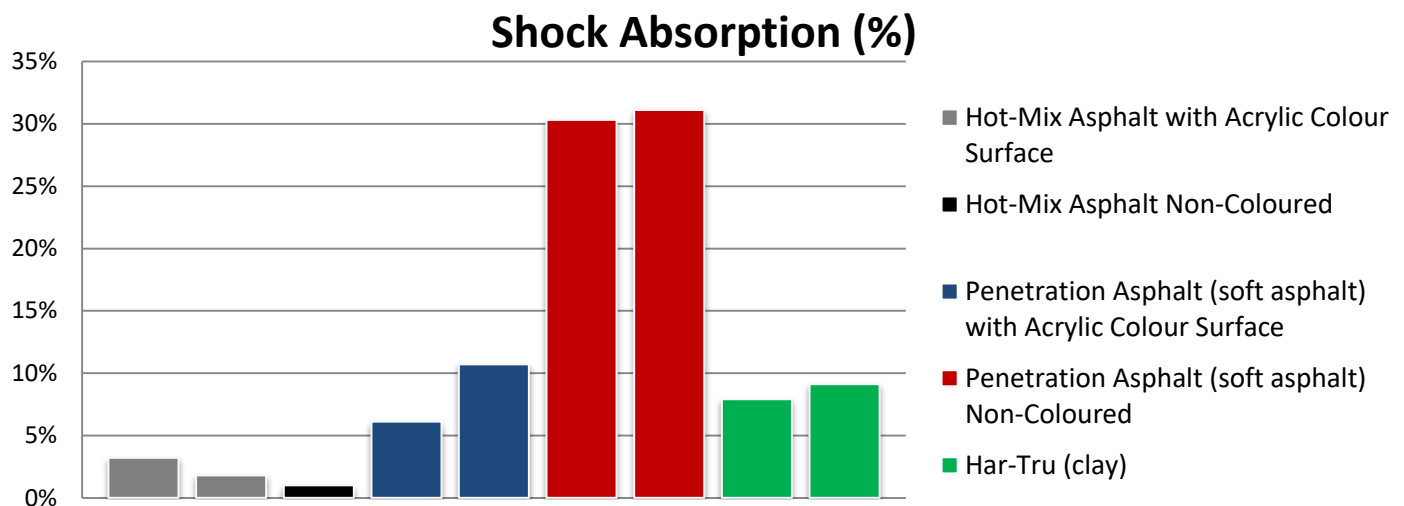
GRAPHIC REPRESENTATION

A surface that gives low shock absorption and vertical deformation values is most likely considered a harder surface than one with opposite performances.

Of all surfaces tested, those at Location 3 (*Berczy Park North*) showed the highest shock absorption and vertical deformation values, and the lowest values were obtained on Location 1 surfaces (*Willowheights Park*).

Location	Type of surface	Property		
		Shock Absorption	Vertical Deformation	Energy Restitution
Willowheights Park	Hot-Mix Asphalt with Acrylic Colour Surface	3.2 %	0.2 mm	87.3 %
	Hot-Mix Asphalt with Acrylic Colour Surface	1.8 %	0.2 mm	89.4 %
	Hot-Mix Asphalt Non-Coloured	1.0 %	0.2 mm	88.2 %
Unionville Tennis Club	Har-Tru (clay)	7.9 %	0.5 mm	80.4 %
	Har-Tru (clay)	9.1 %	0.5 mm	77.9 %
	Penetration (soft) Asphalt + Acrylic Colour Surface	6.1 %	0.4 mm	80.6 %
	Penetration (soft) Asphalt + Acrylic Colour Surface	10.7 %	0.7 mm	74.1 %
Berczy Park North	Penetration Asphalt (soft asphalt) Non-Coloured	30.3 %	1.8 mm	42.6 %
	Penetration Asphalt (soft asphalt) Non-Coloured	31.1 %	1.9 mm	40.0 %
